FINAL REPORT

DEVELOPMENT OF MAINSHAFT SEALS FOR ADVANCED AIR BREATHING PROPULSION SYSTEMS

PRATT & WHITNEY AIRCRAFT
DIVISION OF UNITED AIRCRAFT CORPORATION

NASA LEWIS RESEARCH CENTER
CONTRACT NAS3-15346
L. P. LUDWIG, PROJECT MANAGER

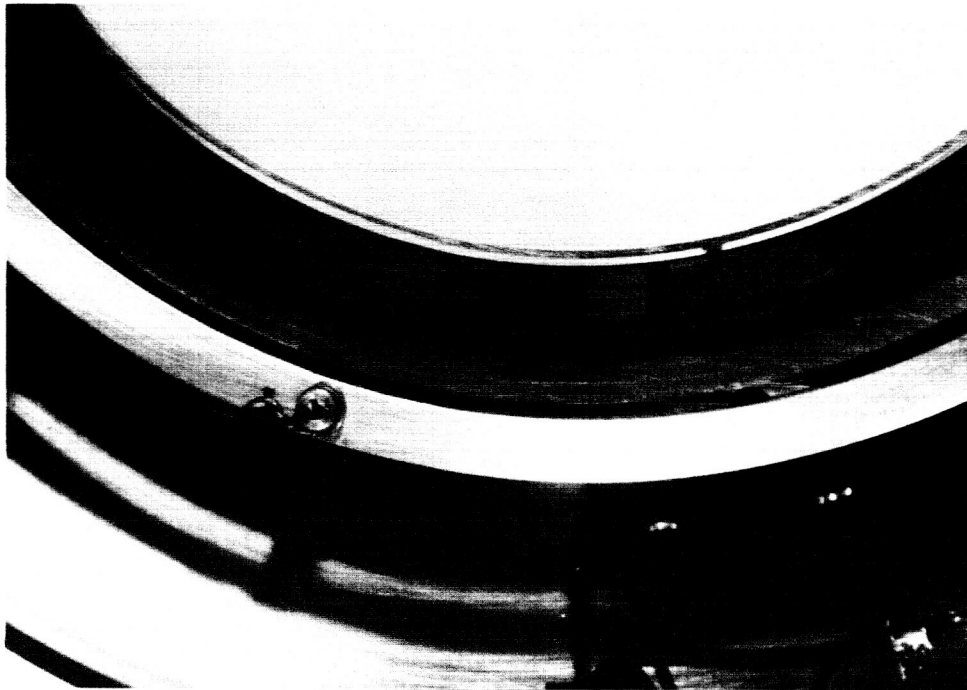
Figure 36 Carbon Nosepiece After 95 Hours at Elevated Temperature Testing (XPN-30630)

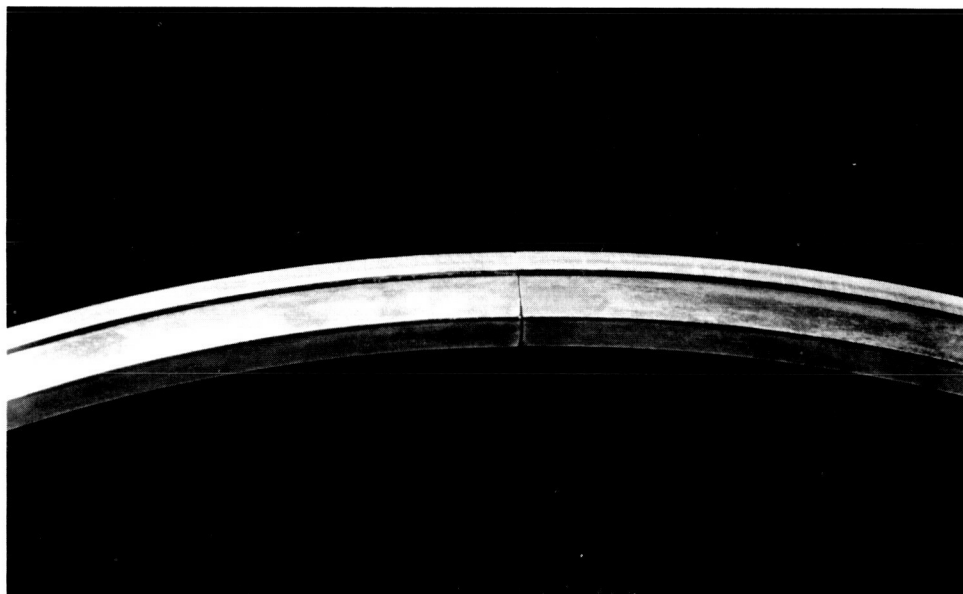
Figure 41 Haynes Alloy 25 Secondary Seal Piston Ring Showing Closed Gap. Total Time of 41 Hours on Piston Ring at Elevated Temperature Conditions (XPN-36435)

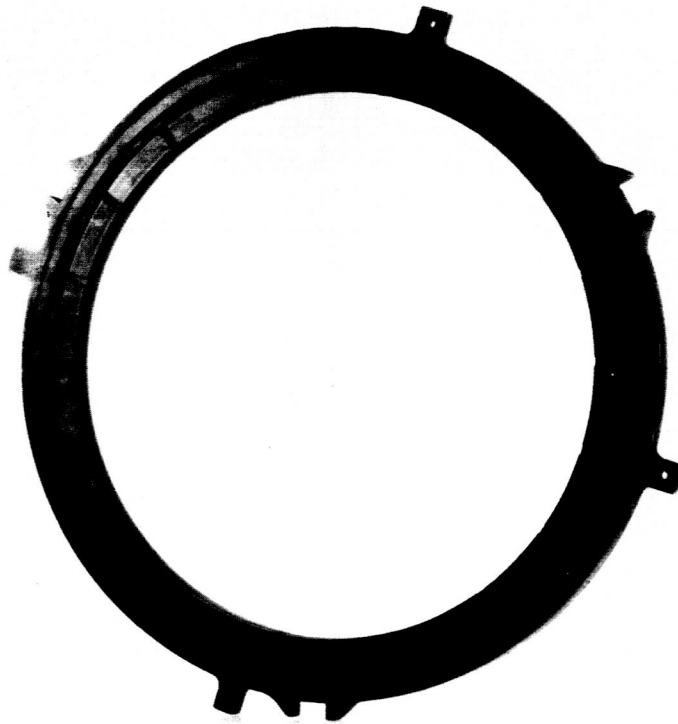
Figure 64 Seal Nosepiece After Completing First 10.5 Hours Contaminated Air Test.
Total Time on Seal 11 Hours (XPN-36569)

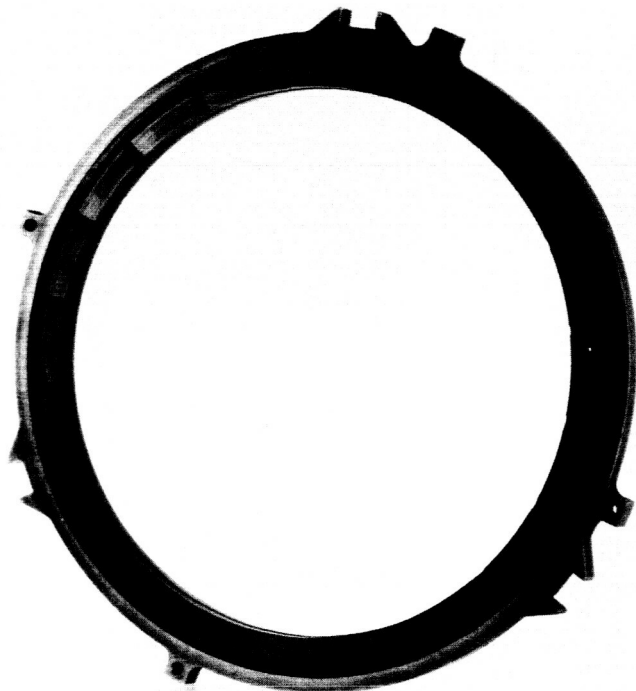
Figure 68 Seal Nosepiece After Completing Second Contaminated Air Test Using Dirt
Windback. Total Time on Seal 14.5 Hours (XPN-36570)
